### **Roof Inspection Check**

Building Name: The Braggs Level 5 - East

**Building No: NT 20**

Date of Inspection: 26/07/2023

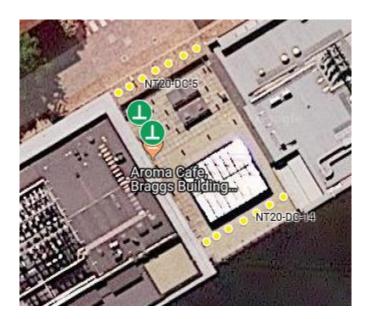
Anchors and davit cups
